Safety and quality are of particular importance in the chemicals industry. Protecting employees, the environment and the load itself take priority. With the new quality-assured EPAL CP pallets, EPAL is closing a major gap in the chemicals industry's logistics chain. You can obtain EPAL CP pallets 1 - 9 from any one of the more than 1,500 licensed manufacturers and repairers. Supplier search under www.epal.eu.

Facts & figures

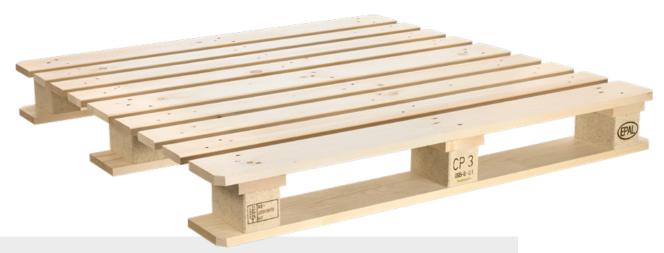
Materials: 15 boards of quality timber, 9 woodchip or solid wood blocks, 81 nails. Produced according to the EPAL Technical Regulations.

ngth	1,140 mm
dth	1,140 mm
ight	138 mm

XX-X) 00000 EPAL in oval on the righthand corner block.

IPPC symbol, country code, registration number of the national plant protection authority, heat treatment on the left-hand corner block.

CP type marking and EPAL ID number (licence number-year-month) on the central block.

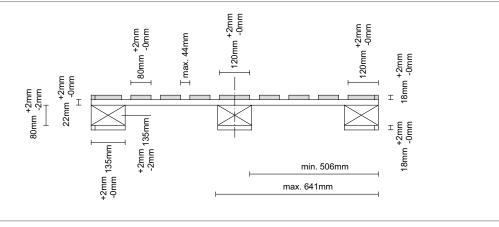
1,140 mm Side
