# EPAL CP9 Pallet

1,140 x 1,140 mm

European Pallet Association e.V.

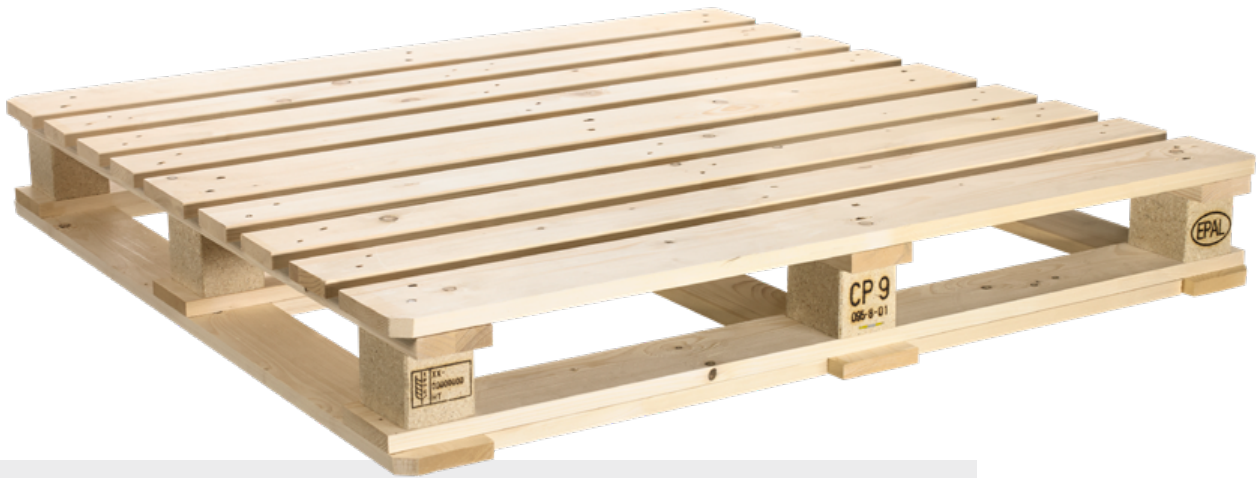
Materials: 24 boards of quality timber, 9 wood-chip or solid wood blocks, 102 nails. Produced according to the EPAL Technical Regulations.

Length	1,140 mm
Width	1,140 mm
Height	156 mm
