The work of the European Pallet Association, its National Committees and licensees forms the stable basis for the successful, open pallet pool and enables the global exchange of EPAL load carriers. The new EPAL 7 half pallet is more robust and longer lasting than the current "Düsseldorfer" half pallet used on the market. The new EPAL 7 half pallets are particularly popular in the drinks and food industry, as well as with discount stores and the retail trade. Constant quality assurance and high quality materials ensure trouble-free, safe performance for users and loading. Their multiple use saves a considerable amount of environmental and economic resources

FACTS & FIGURES

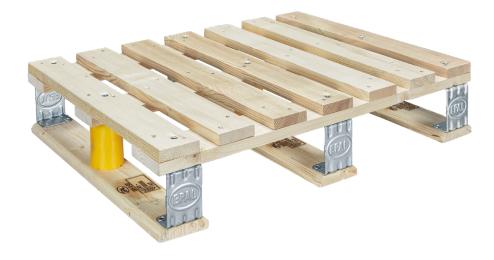
Materials: 13 boards of guality timber, 3 blocks, 42 nails, 6 sturdy 3-mm steel angle brackets, 21 tubular rivets. Produced according to the EPAL Technical Regulations.

Length	800 mm
Width	600 mm
Height	163 mm
Weight	Approx. 9.5 kg
Safe working load	500 kg

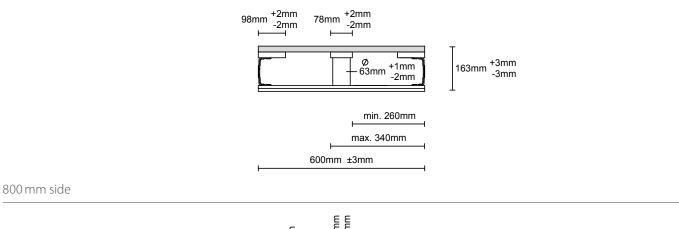
600 mm side

"EPAL in oval" on the three steel EPA angle brackets on the long side.

IPPC symbol, country code, registration number of the national plant protection authority, heat treatment, licence number-year-month and "EPAL in oval" on the top side of the bottom boards.
